6400 Line Matrix Printers - what's new 3/11/2004

Double Hammer bank PQ notes (Models x20 and i24 only):
Determining if problem is banding, platen camshaft alignment, or platen angle adjustment.
(revised 07/24/03)

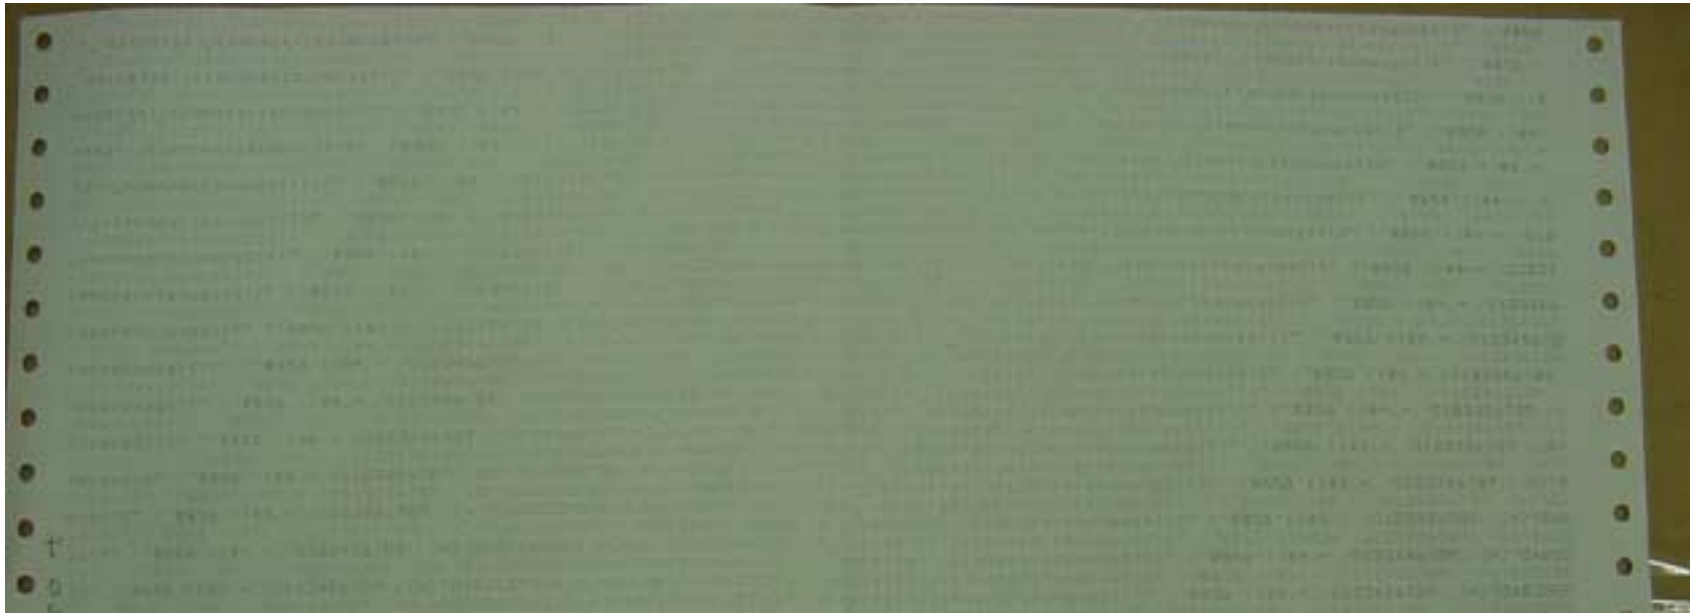
Banding:

The above picture shows banding. Note that one line starts out dark on the left side and transitions to light towards the right. The next line starts out light on the left side and transitions to dark on the right. This repeats every other line. Do not be concerned about the lightness of the print in this picture. It is just to illustrate the "banding" effect.

If this is the case, return to the Banding section of the MIM.

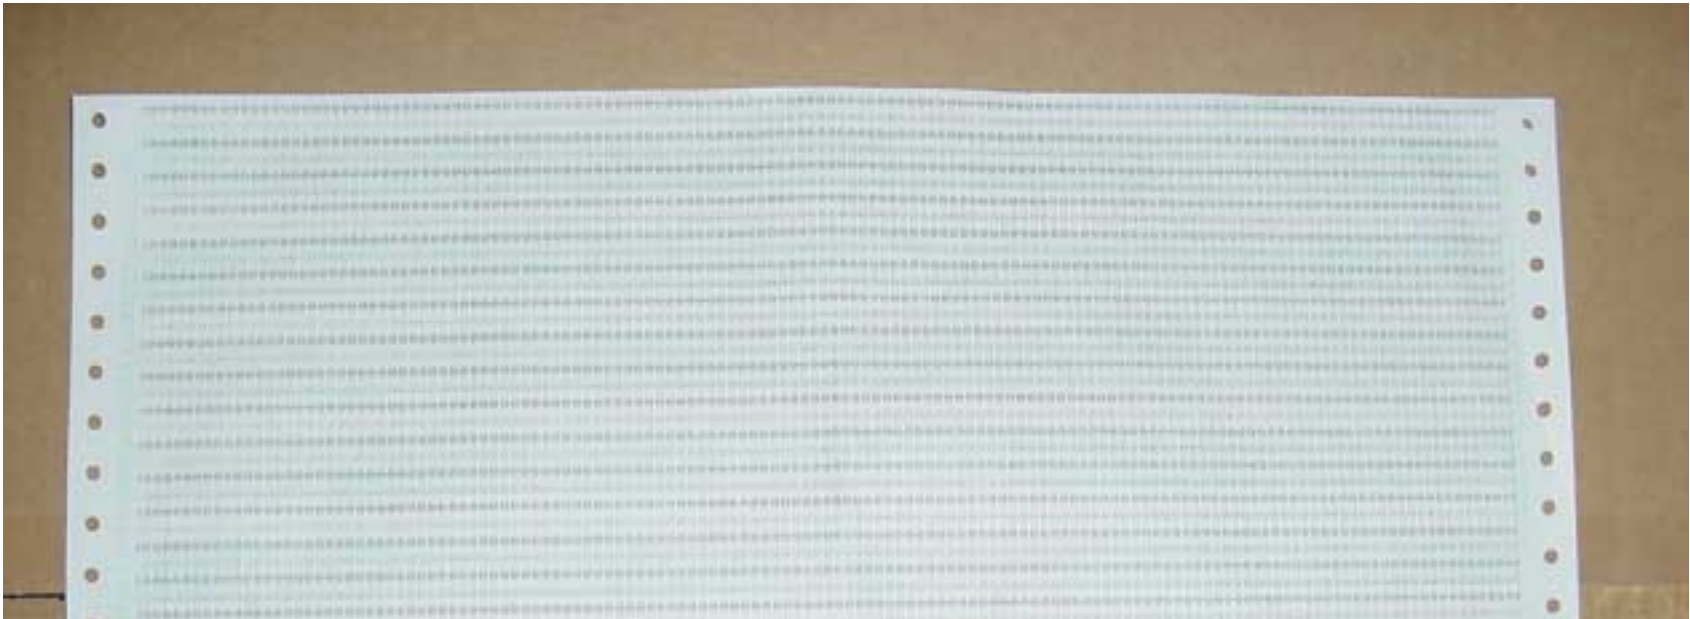
Platen angle adjustment:

The following picture shows platen angle misalignment.

Note that one line is uniformly dark across the page. The next line is uniformly light across the page. This repeats

very other line.

If the print problem looks like the above picture, continue with the platen angle adjustment procedure.

If you confirm a misaligned platen angle, we recommend that you contact your DDS and second-level support, for guidance. This is the procedure that they would be walking you through:
